Experimental Evaluation of Seismic Residual Performance for Deteriorated Rubber Bearings in Highway Bridges

6th International Conference on Advances in Experimental Structural Engineering
11th International Workshop on Advanced Smart Materials and Smart Structures Technology
August 1-2, 2015, University of Illinois, Urbana-Champaign, United States

Kunihiro HAYASHI¹, Yukio ADACHI², Naota SAKAMOTO³, Akira IGARASHI⁴
and Ji DANG⁵

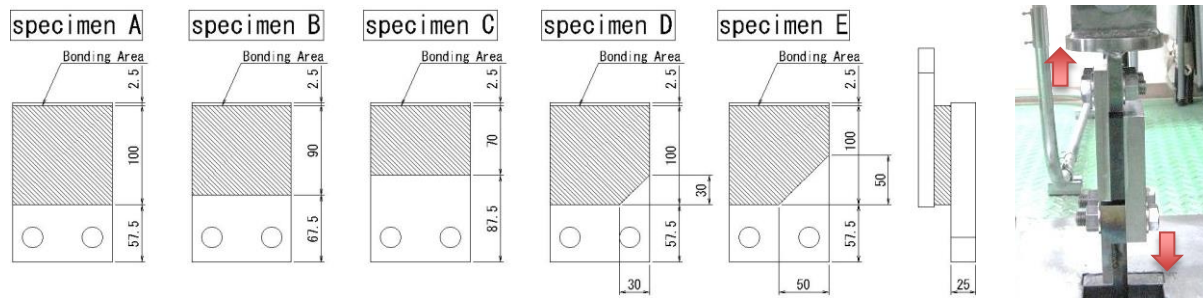
Figure 3.8 Specimens of lap shear tests

The lap shear tests were carried out to evaluate the influence of rubber surface cracks and debonding between the steel plate and rubber on the seismic performance of the bearing. As shown in Figure 3.8, five types of specimen (A~E) taken from differed distances from the bonding area and shape were prepared, and the failure strength in shearing direction were measured. The test results are shown in Figure 3.9.

The difference of the failure stresses between the specimens is not significant. It is also noteworthy that the results of the specimen E are in the same range in spite of possible high stress concentration in the specimen E due to partly cutout. When a good bonding condition is ensured, the bonding between the steel plate and rubber is not regarded as a critical factor for the cause of rupture and failure of the bearing.
